TECHNICAL SERVICE BULLETIN

2019-2021 Transit - Driver Seat Cushion Sagging - Built On Or Before 11-Feb-2021

24-2053
14 March 2024

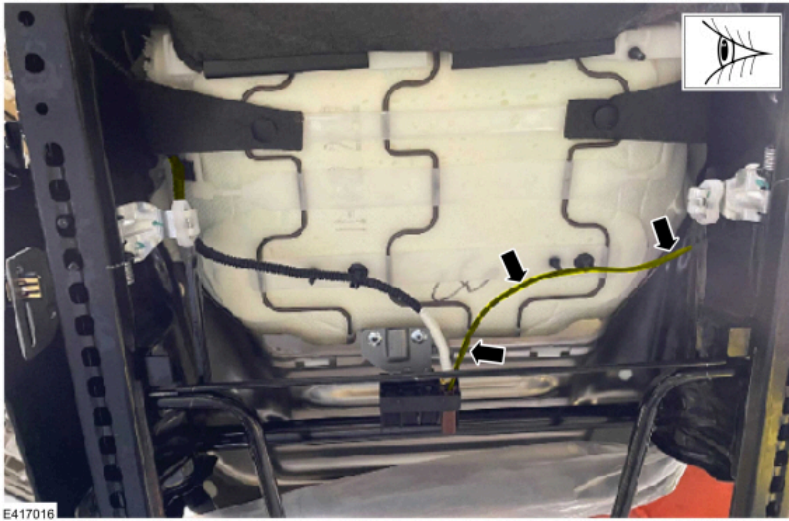
Figure 1

1. Remove the affected driver seat track. Refer to W_{SM}, Section 501-10A, starting with Step 2.
2. Inspect the seat airbag deployment circuit for damage as shown in Figure 1. If damage is present, replace the side airbag. Refer to W_{SM}, Section 501-20B.

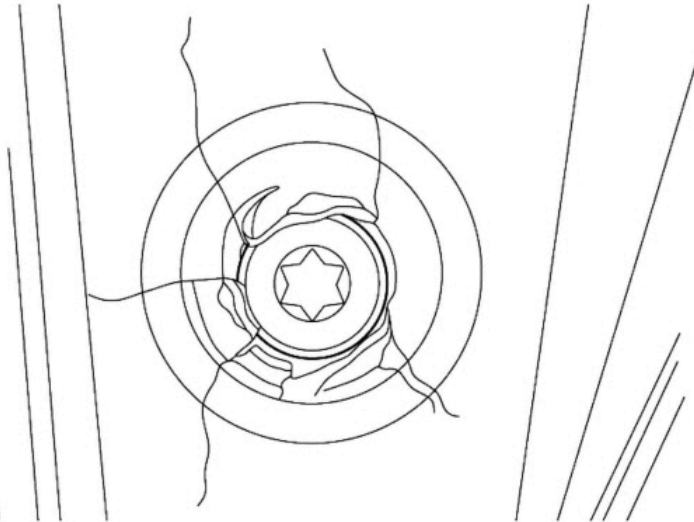
Figure 2

3. Inspect the driver seat track assembly for damage. Is the driver seat track assembly damaged?

NOTE: Small cracks around the bolt are considered normal. (Figure 2)

- (1). Yes - replace the seat track assembly. Refer to WSM, Section 501-10A Front Seats > Removal and Installation > Front Seat Track. Proceed to Step 5.
- (2). No - proceed to Step 4.

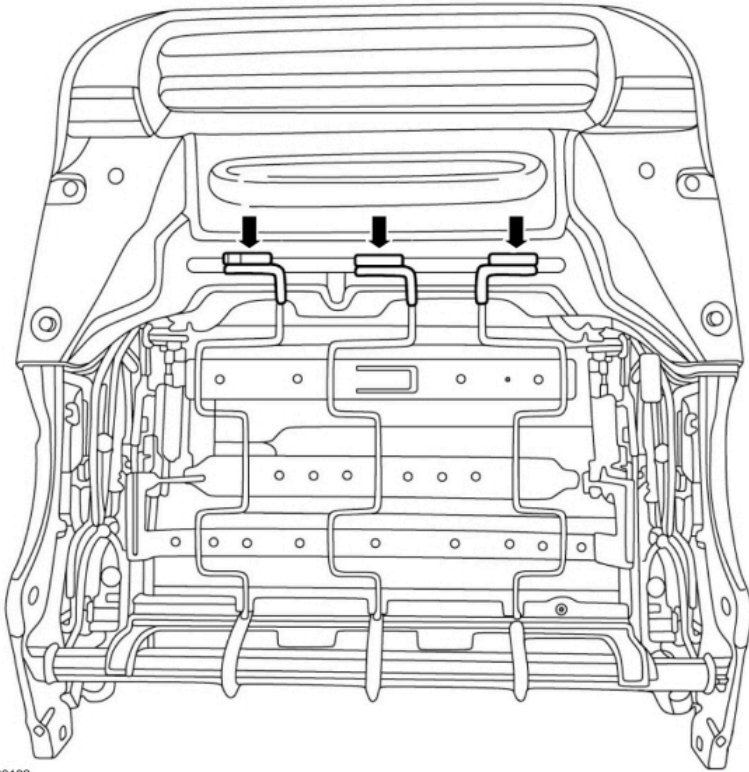
Figure 3

- (1). Remove all wire harness attachments (fir trees) from the suspension mat assembly.
- (2). Disengage the 3 suspension mat assembly forward attachments from the cushion pan. (Figure 3)

- (3). Remove the suspension mat assembly 3 rearward attachments. The suspension mat assembly has a snap fit on the rear tube. (Figure 3)
- 5. Install 2 webbing straps assemblies. Installation shown from the under-side of cushion assembly.
 - (1). With the red thread visible, route the end of the 1st webbing strap assembly without the metal ring between the cushion pan and the front cross-car tube. (Figure 4)

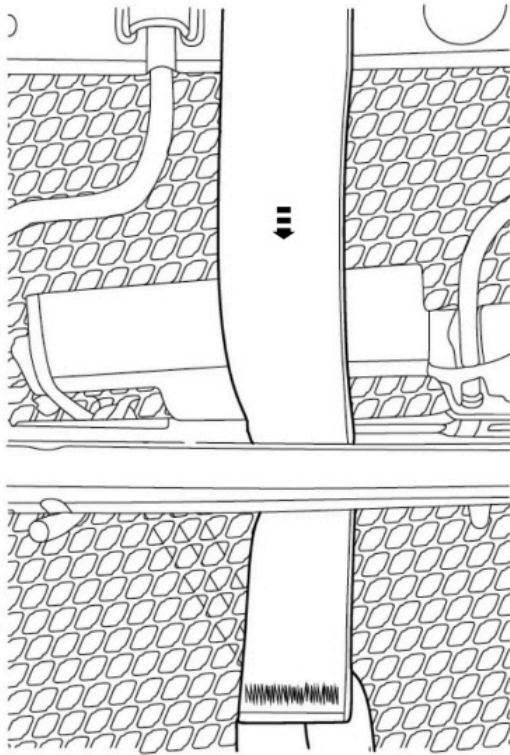
- (2). Continue rearward and route the webbing strap assembly between the suspension mat assembly and the rear tube. (Figure 5)
- Figure 5

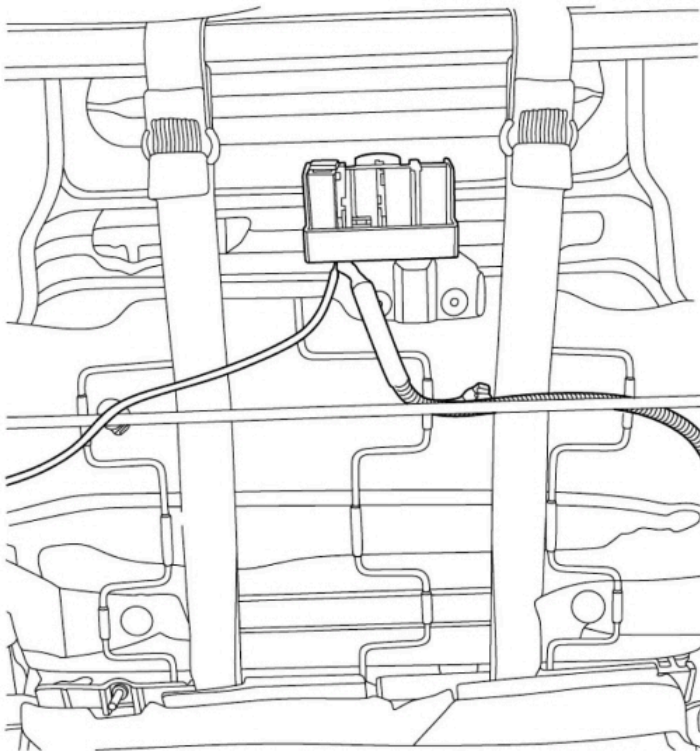
Figure 6

(3). Make sure all electrical harnesses are below the webbing. The final assembly will have the suspension mat on top (closest to the seat cushion), then the webbing straps, and then the wire harnesses on the bottom. (Figure 6)

NOTE: Make sure all electrical harnesses hang below the webbing and not between the webbing and suspension mat. When the final assembly is installed in the vehicle, it will have the suspension mat on top (closest to the cushion), then the webbing straps, and then the wire harnesses on the bottom. (Figure 6)

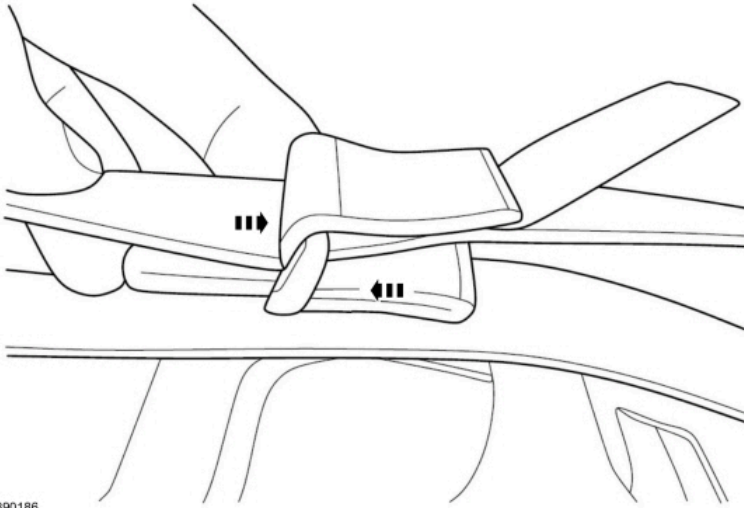
Figure 7

(4). Bring the webbing strap assembly to the metal ring and insert it. After the fold is all the way through the ring, pull the retention fold back and into position. (Figure 7)

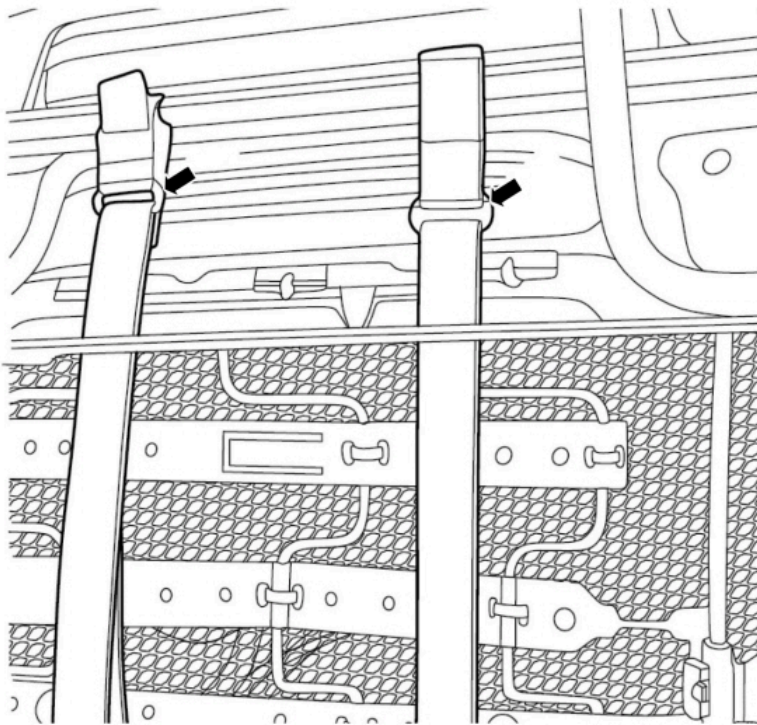
Figure 8

- (5). Repeat the process to install the second webbing strap assembly.
- (6). The metal ring should be positioned forward in vehicle. (Figure 8)

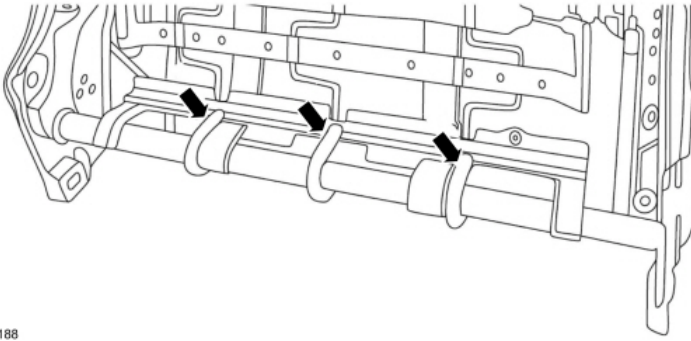
Figure 9

6. Install the new suspension mat assembly from the service kit.
 - (1). Locate the suspension mat to the cushion and webbing assembly.
 - (2). At the rear tube verify one webbing is located between the left and center suspension attachment and the other is between the center and right suspension attachment. (Figure 9)

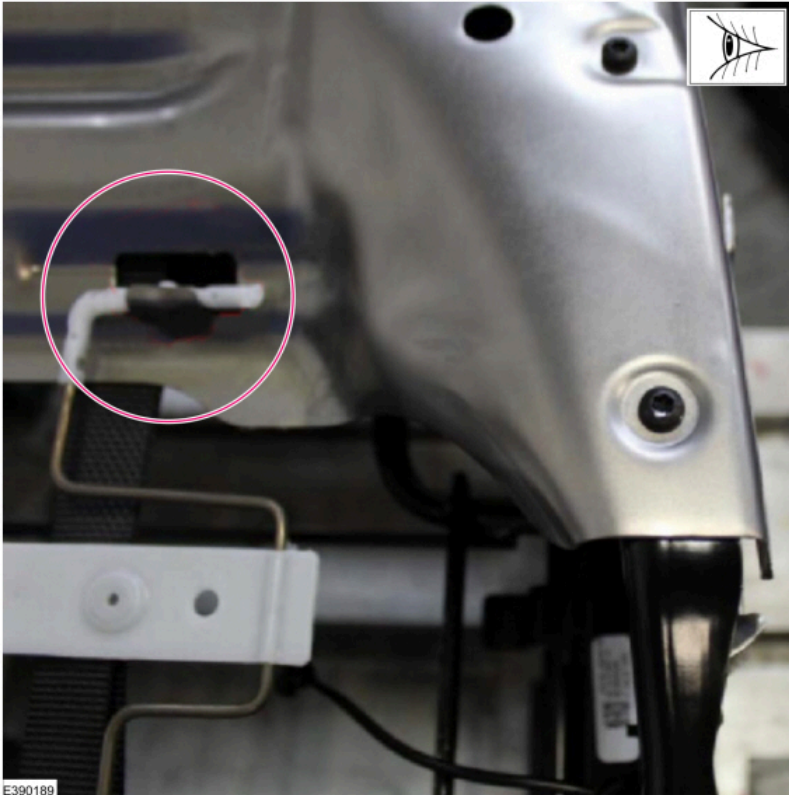
Figure 10

(4). Secure the front of the suspension mat to the retaining tabs on the cushion pan (no tools required). (Figure 10)

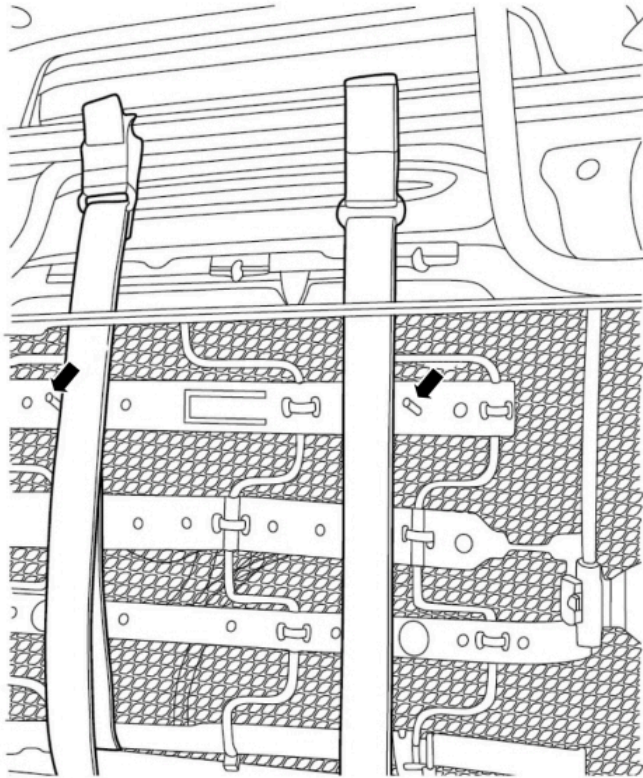
Figure 11

(5). Verify the cross-car position of the webbings. The position should be aligned with the stud on the suspension mat. (Figure 11)

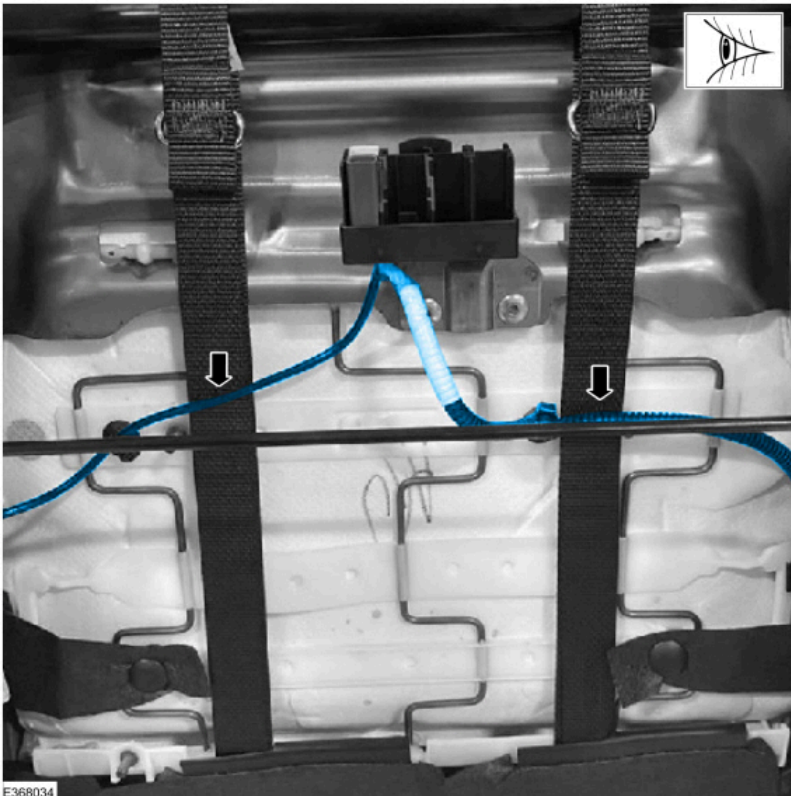
Figure 12

(6). Secure the wire harness(es) to the suspension mat. (Figure 12)

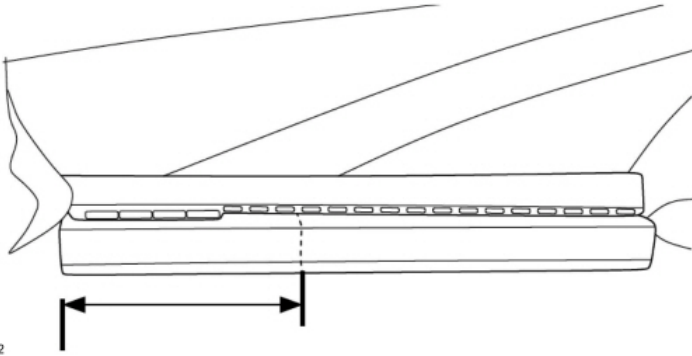
Figure 13

(1). Measure 1 3/4 in. (45 mm) and cut with a knife along the dotted line. (Figure 13)

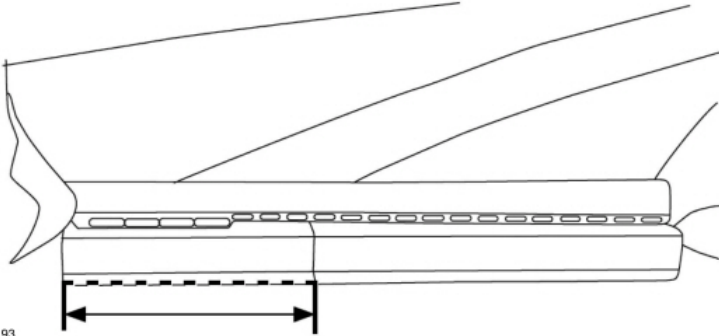
(2). Cut along the dotted line (Figures 14-15), perpendicular to the previous cut, so that the portion of the J retainer in Figures 16 and 17 can be removed.
Figure 14
