## TECHNICAL SERVICE BULLETIN

### Crew Cab - Folding Rear Seat Backrest Assembly Excessive Latching Effort When Returning To The Upright Position

**21-2036**16 February  
2021

| <b>Ford</b><br>2019-2021 Ranger |

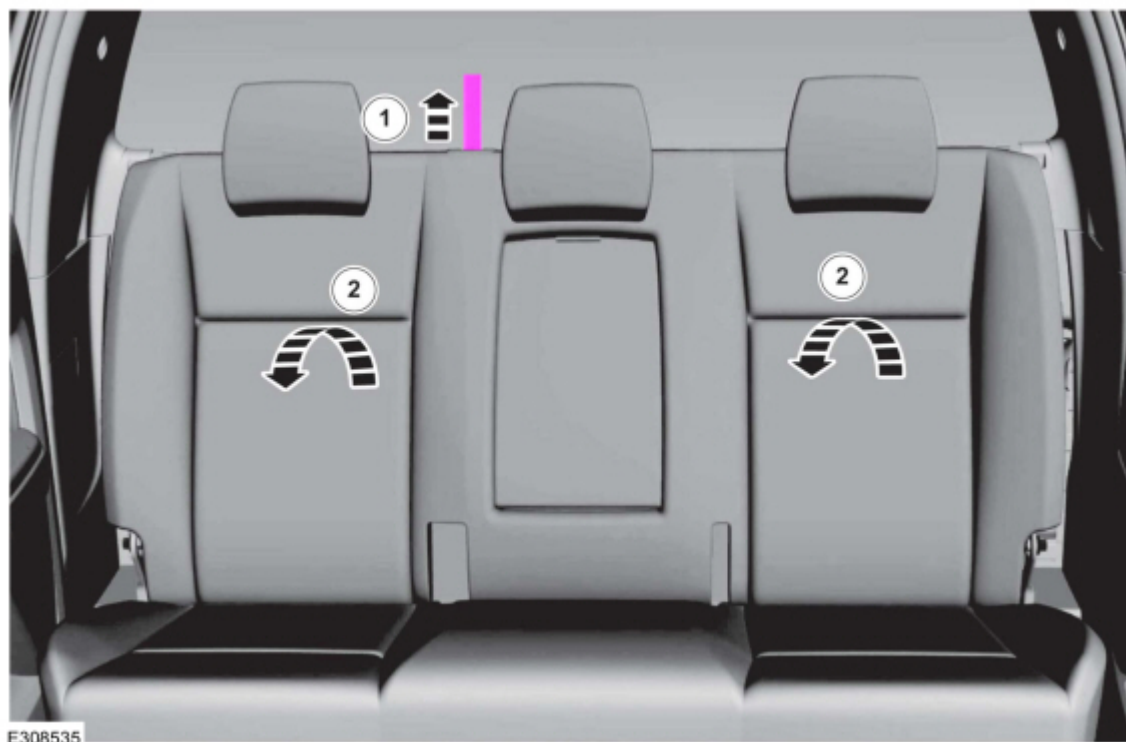
Figure 1

- Check the vehicle build date. Was the vehicle built on or before 04-Feb-2019?
  - Yes – proceed to Step 2.
  - No – proceed to Step 14.
- Release the rear seat backrest latch (Figure 1 Callout 1) and lower to the fold flat position. (Figure 1 Callout 2)

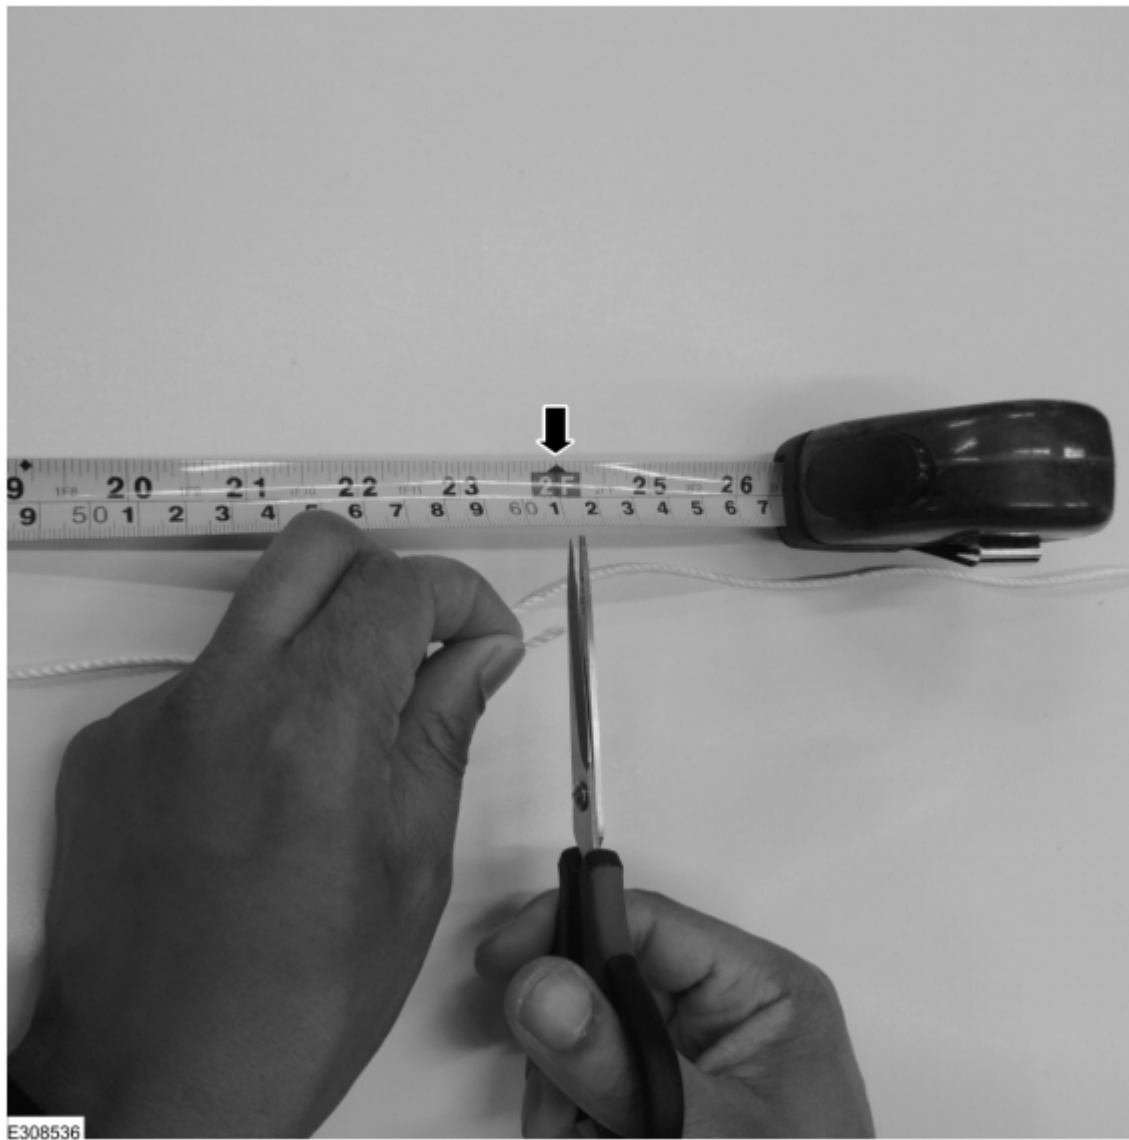
Figure 2

- Measure and cut a 60 cm (2-foot) piece of string. (Figure 2)

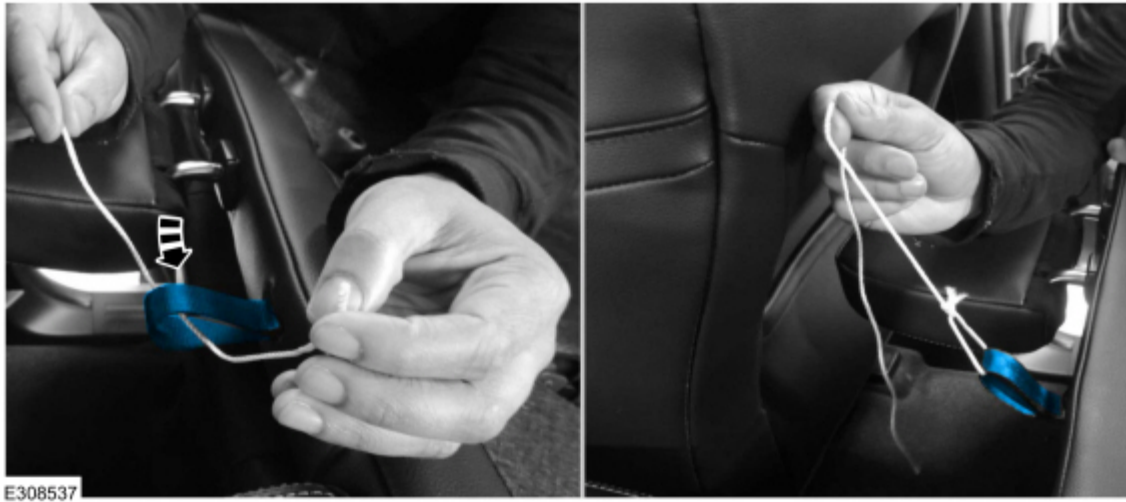
Figure 3

4. Guide the string through the rear seat backrest release strap and double knot a loose loop. (Figure 3)

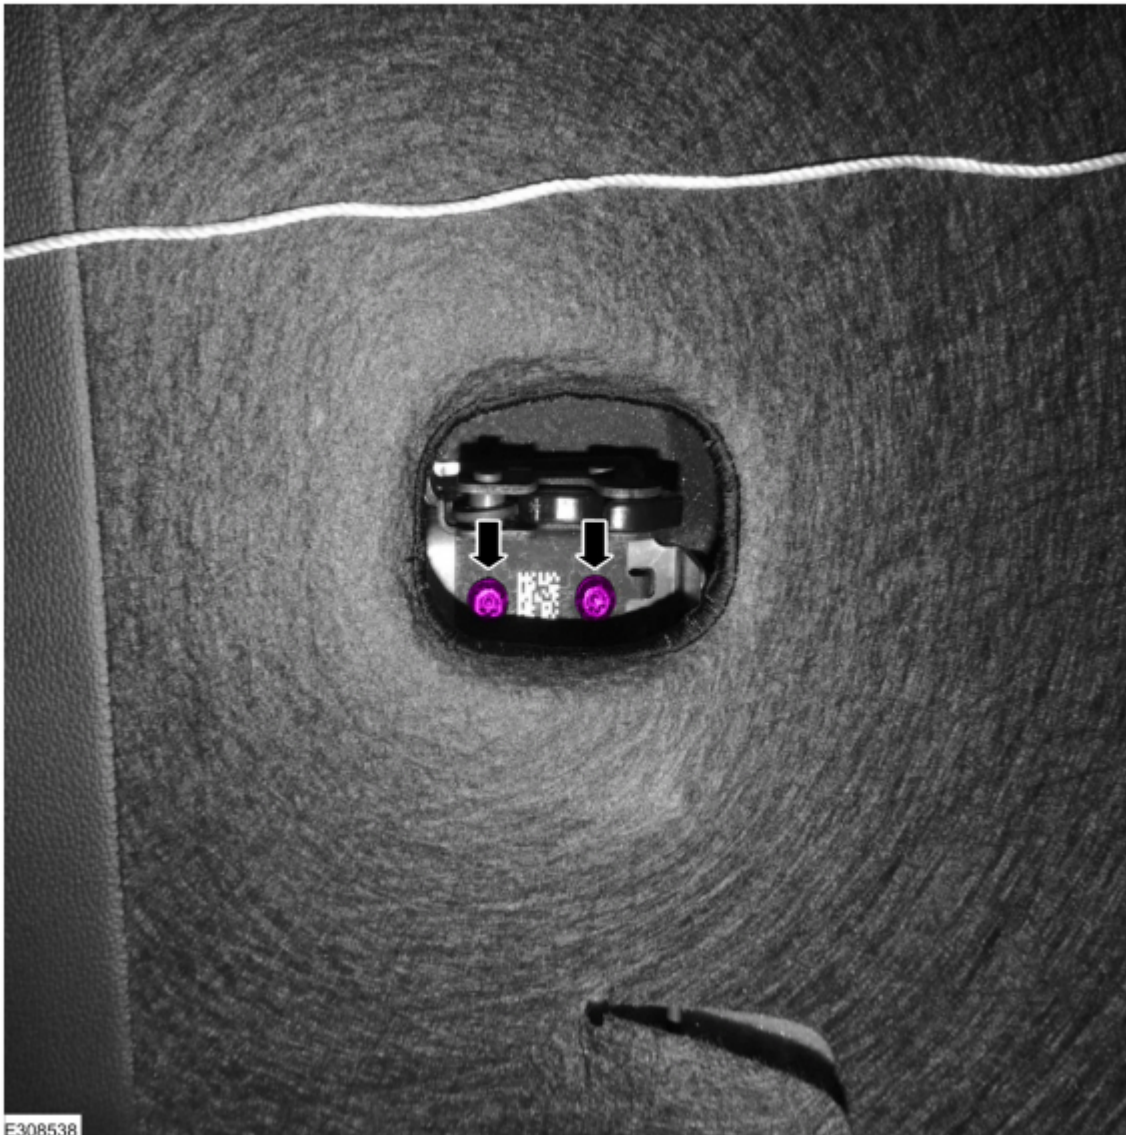
Figure 4

5. Remove the rear seat backrest latch retainers. (Figure 4)

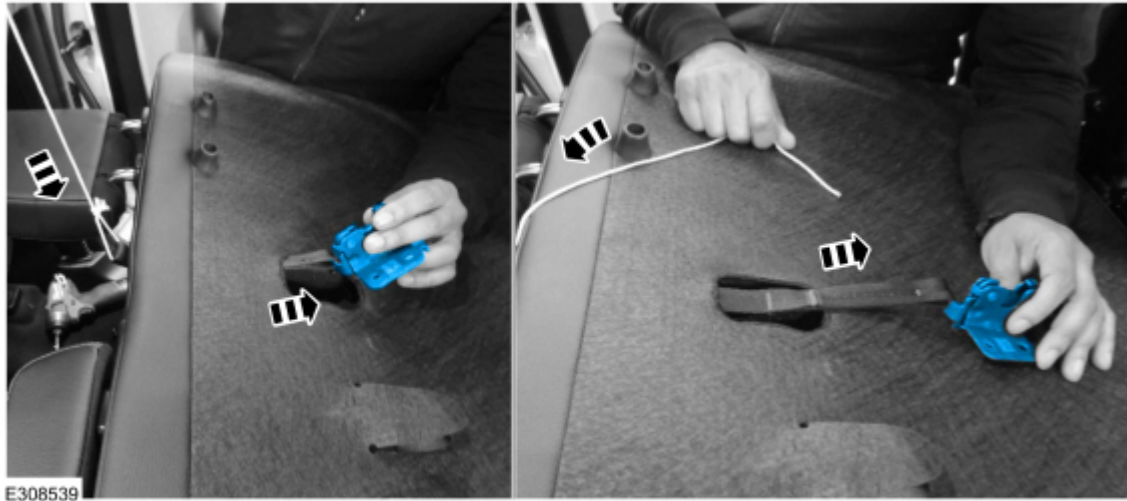
Figure 5

6. Holding the string, guide the rear seat backrest latch up and out of the rear seat backrest assembly just enough to access and remove the rear seat backrest latch release strap. (Figure 5)

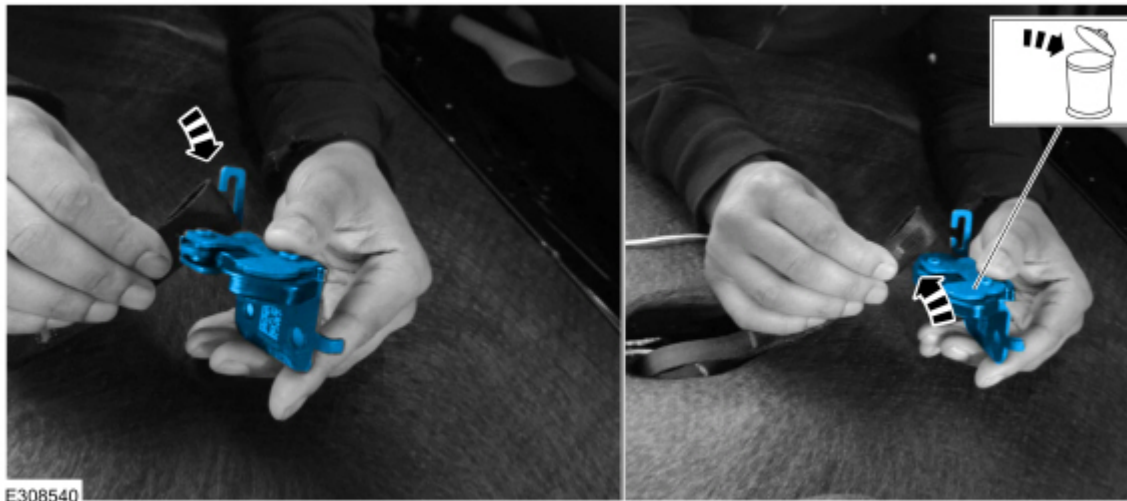
Figure 6

7. Remove and discard the rear seat backrest latch from the rear seat backrest release strap. (Figure 6)

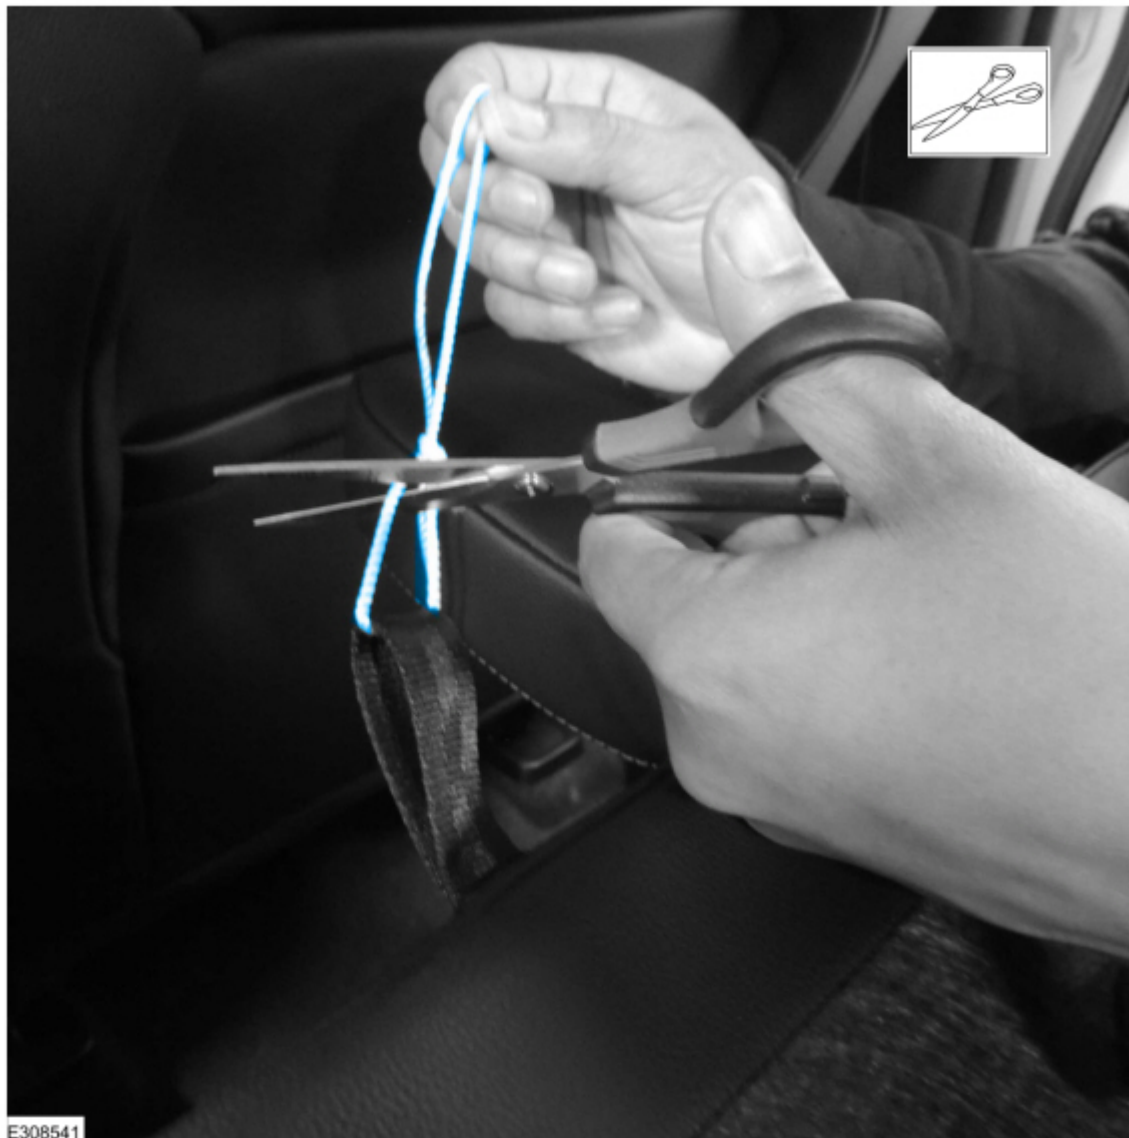
Figure 7

8. Install the rear seat backrest release strap onto the new rear seat backrest latch.
9. Install the new rear seat backrest latch by pulling the string attached to the rear seat backrest release strap back through the seat backrest cover and guiding the rear seat backrest latch back into the rear seat backrest assembly. (Figure 5)
10. Install the rear seat backrest latch retainers. (Figure 4)
- (1). Tighten both retainers to 1.2 Nm (10.6 in-lb).
11. Remove the string attached to the rear seat backrest release strap. (Figure 7) Make sure to cut the string as far away from the rear seat backrest release strap as possible or damage to the release strap may occur.

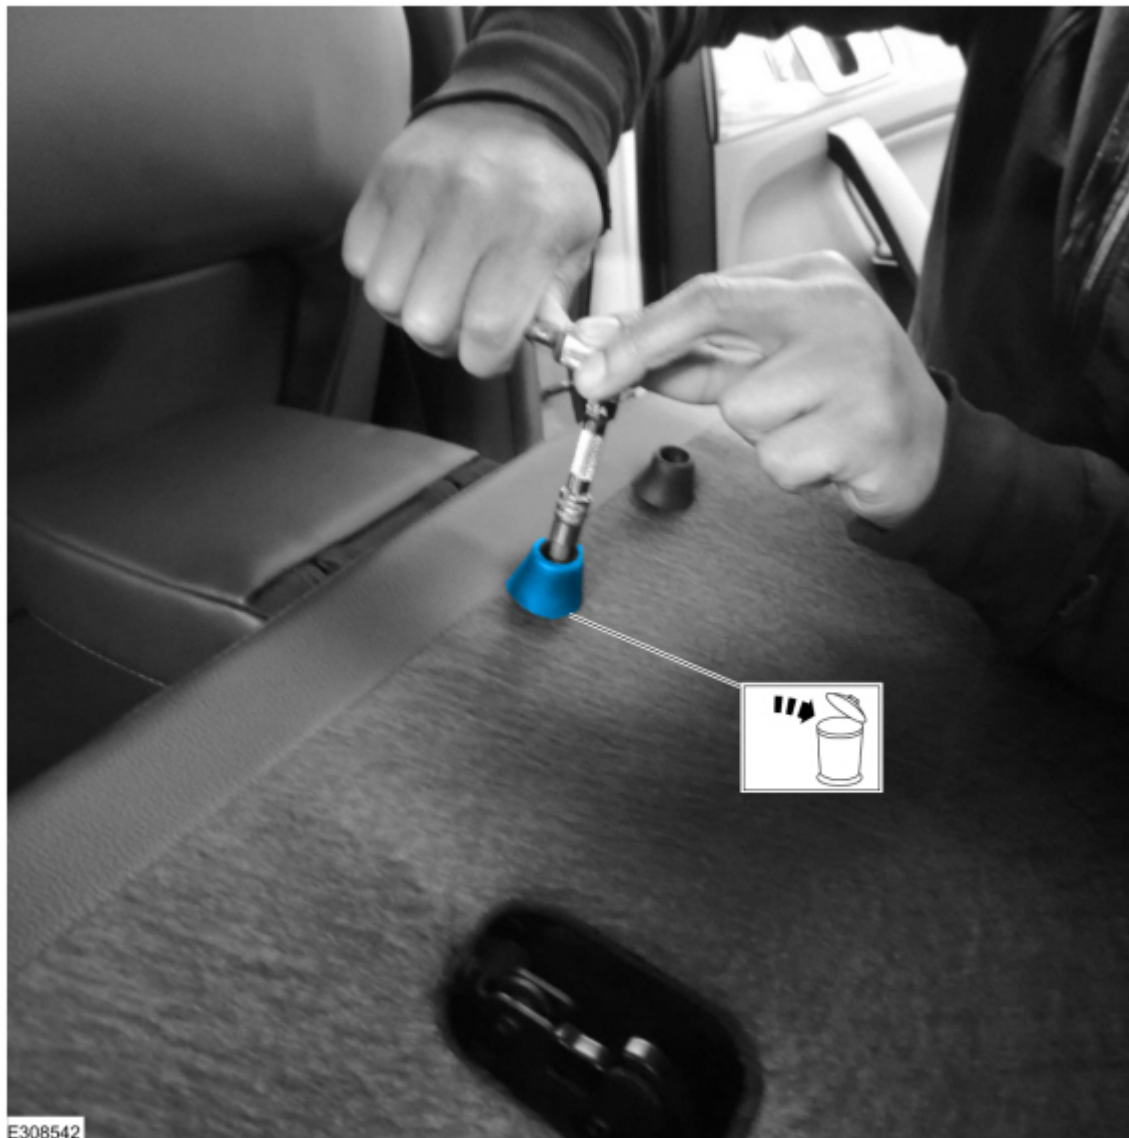
Figure 8

**12.** Remove and discard the passenger side inboard rear seat backrest bumper on the backside of the rear seat backrest assembly. (Figure 8)

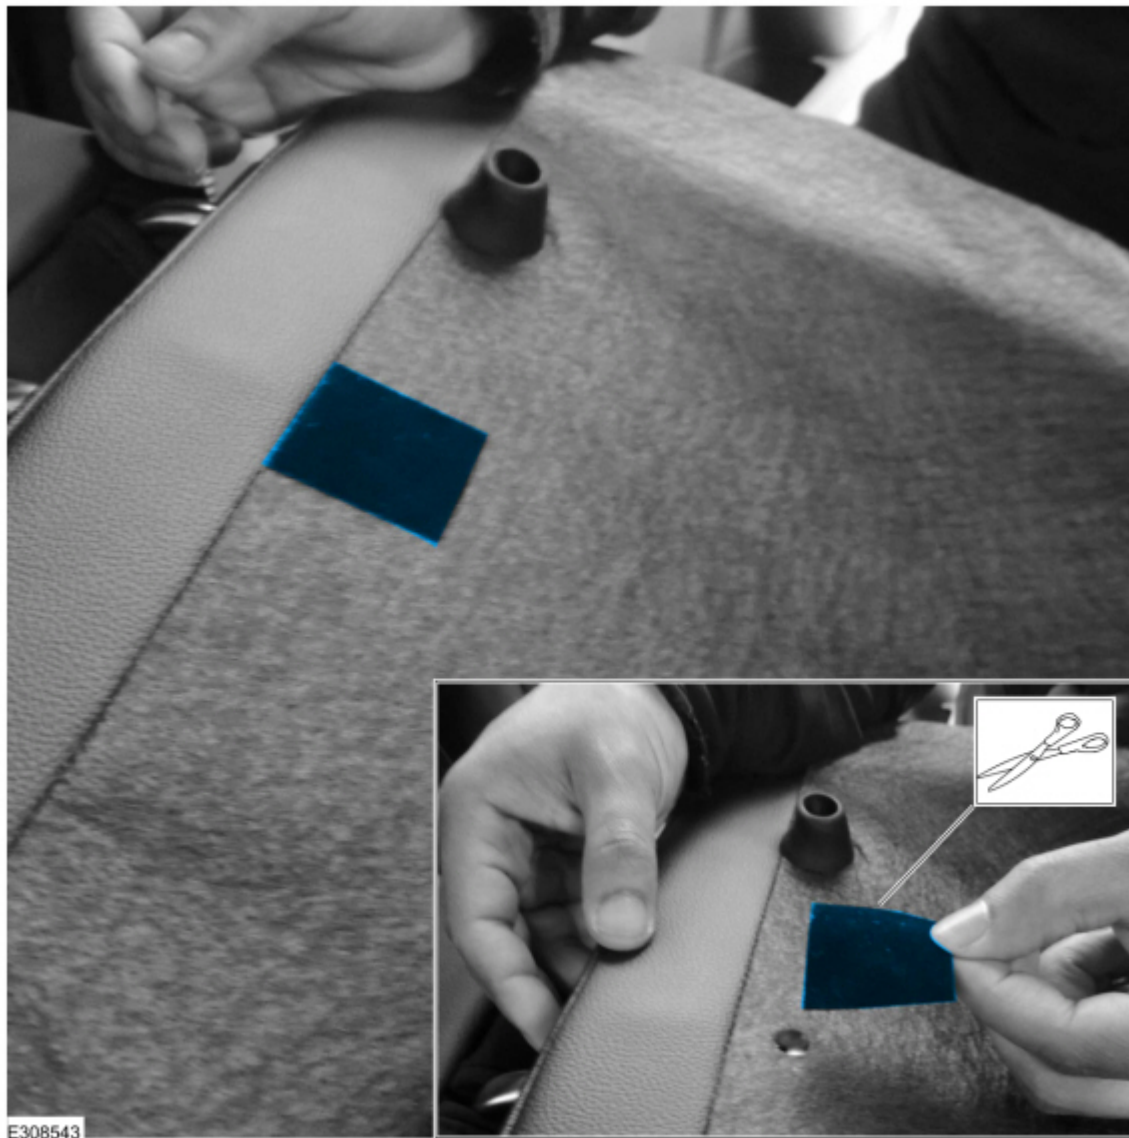
Figure 9

- 13.** Cut a 40 mm by 40 mm (1.5 inch by 1.5 inch) piece of flock tape and install it over the rear seat backrest bumper retainer hole. (Figure 9)

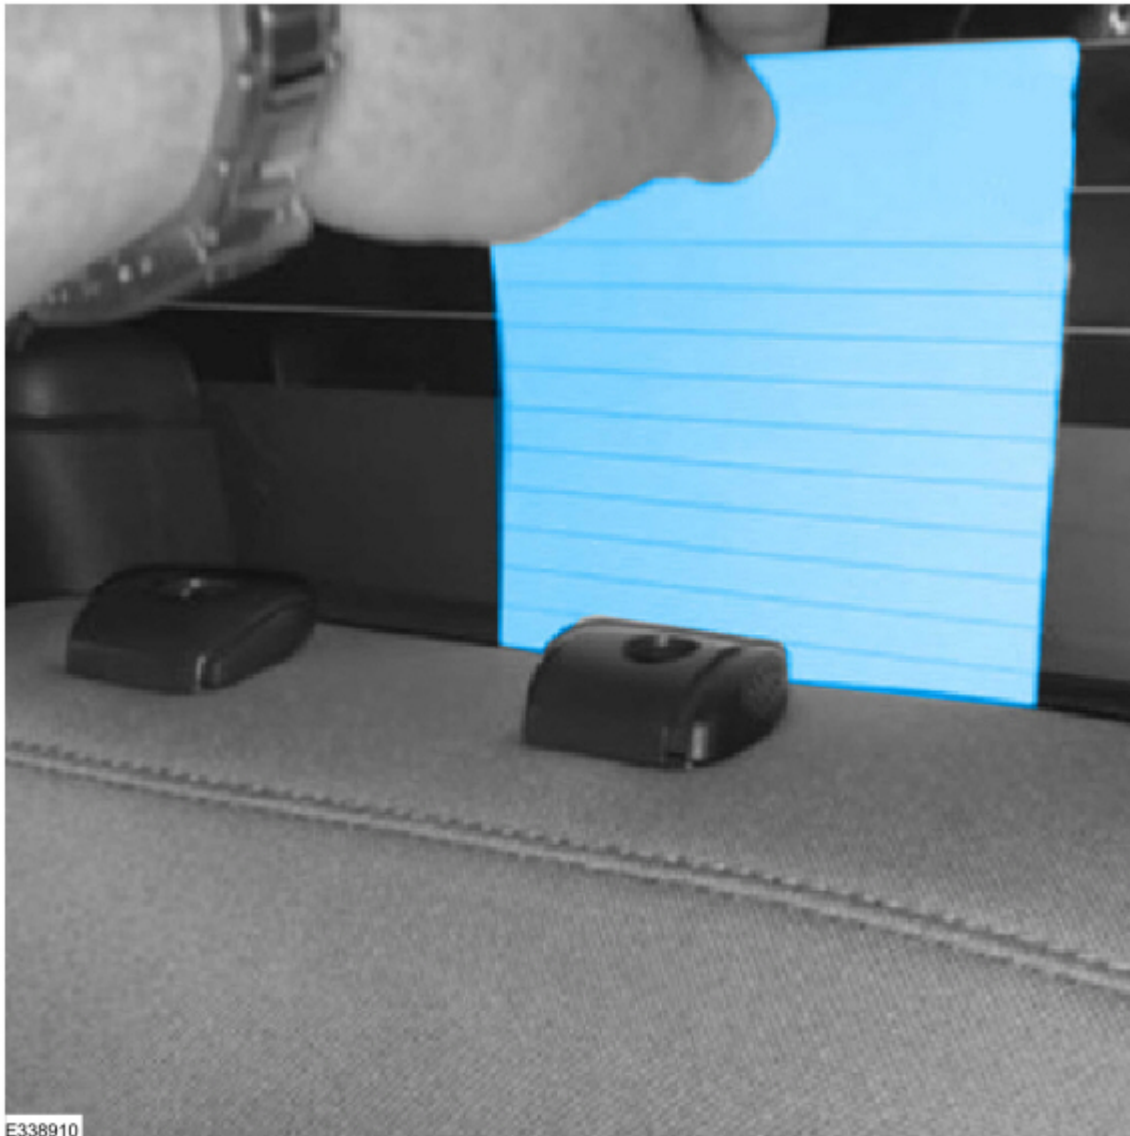
Figure 10

**16.** Perform a drag test using a sheet of paper to determine which of the 3 rear seat backrest bumpers contacts the back of the cab first.

- (1). While covering one rear seat backrest bumper with a sheet of paper, raise the rear seat backrest so it is in the upright position, but not latched, and lightly tug on the paper to determine if that bumper is contacting the rear of the cab. Repeat this test on all 3 bumpers.
- (2). The rear seat backrest bumper that holds the paper will be considered rear seat backrest bumper 'X'. Remember the location of rear seat backrest bumper 'X', as it will be used later in the procedure. (Figure 10)

**NOTE:** If more than one seat backrest bumper is found to be contacting the rear of the cab, the bumper closest to the latch should be considered rear seat backrest bumper 'X'.

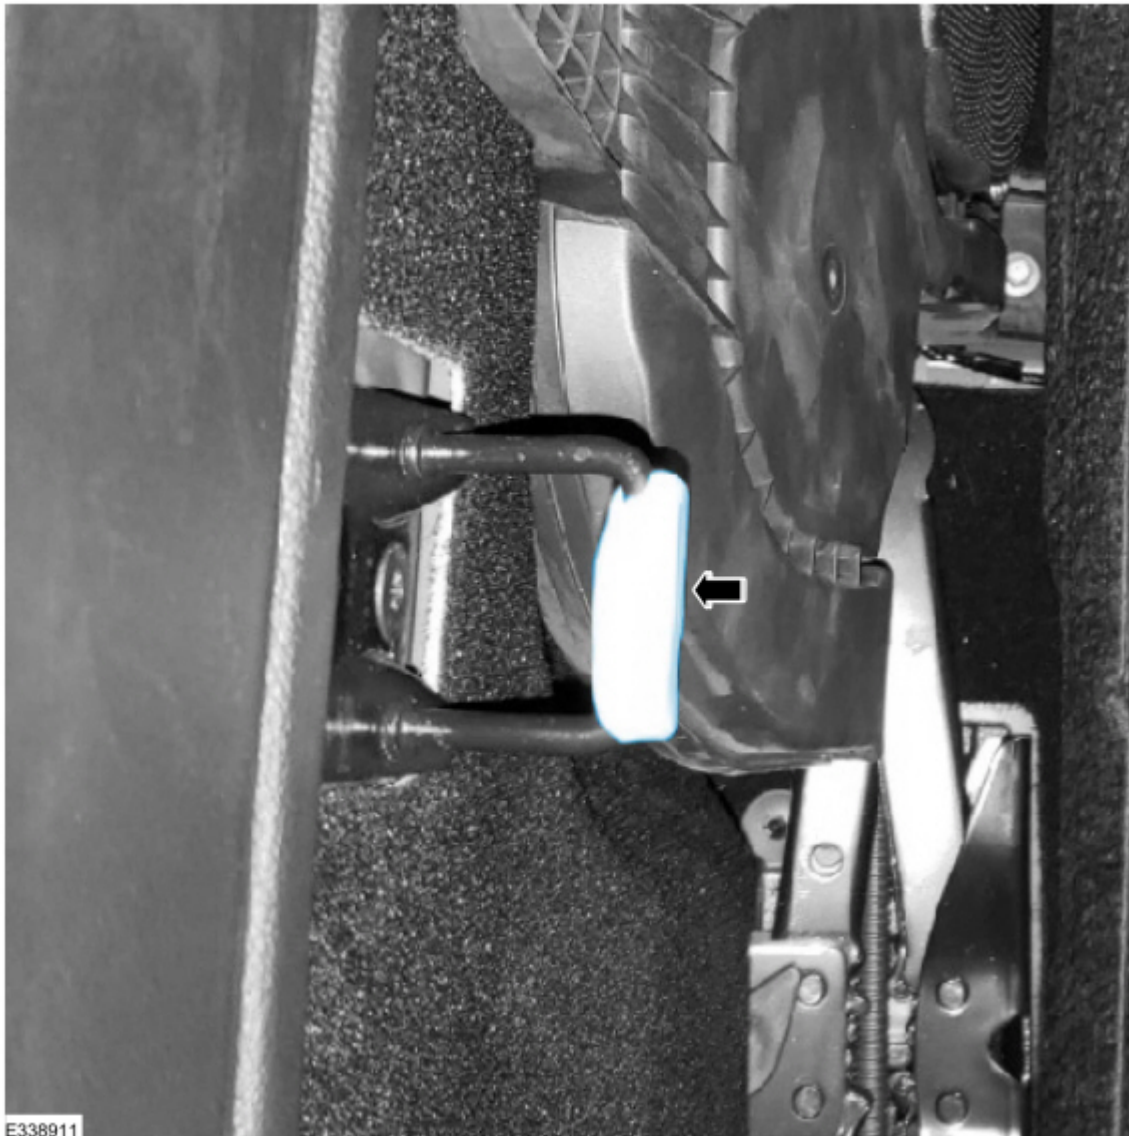
Figure 11

**17.** Use modeling clay to measure the position of the rear seat back rest latch relative to the striker.

- (1). With the rear seat backrest assembly folded to the flat position, apply modeling clay to the width of the striker. The modeling clay should be no more than 5mm thick on the forward side of the striker. (Figure 11)
- (2). While holding a sheet of paper over rear seat backrest bumper 'X', raise the rear seat backrest assembly until vertical.
- (3). Allow gravity to pull the rear seat backrest assembly the rest of the way against the modeling clay while lightly tugging on the paper to confirm when the rear seat backrest bumper 'X' is against the cab. If the paper is not being held, apply very light pressure near rear seat backrest bumper 'X' until resistance can be felt when tugging on the paper.

**NOTE: Applying too much pressure against the rear seat backrest may compress the rear seat backrest bumpers and give a false impression in the modeling clay.**

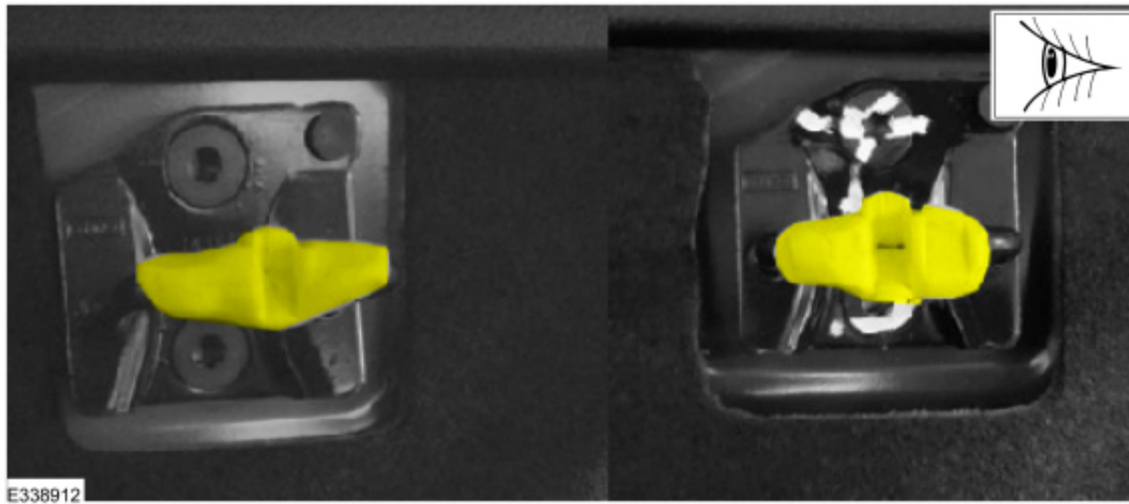
Figure 12

**18.** Lower the rear seat backrest assembly to the fold flat position and inspect the impression in the modeling clay left by the rear seat backrest latch. Is the striker visible through the modeling clay? (Figure 12)

(1). Yes – no adjustments to the rear seat backrest bumpers are necessary, however, material may be removed from the rubber bumpers to reduce seat latching efforts for customer preference, but removing too much material may result in rear seat backrest noise, vibration, and harshness (NVH) concerns.

(2). No – proceed to Step 19.

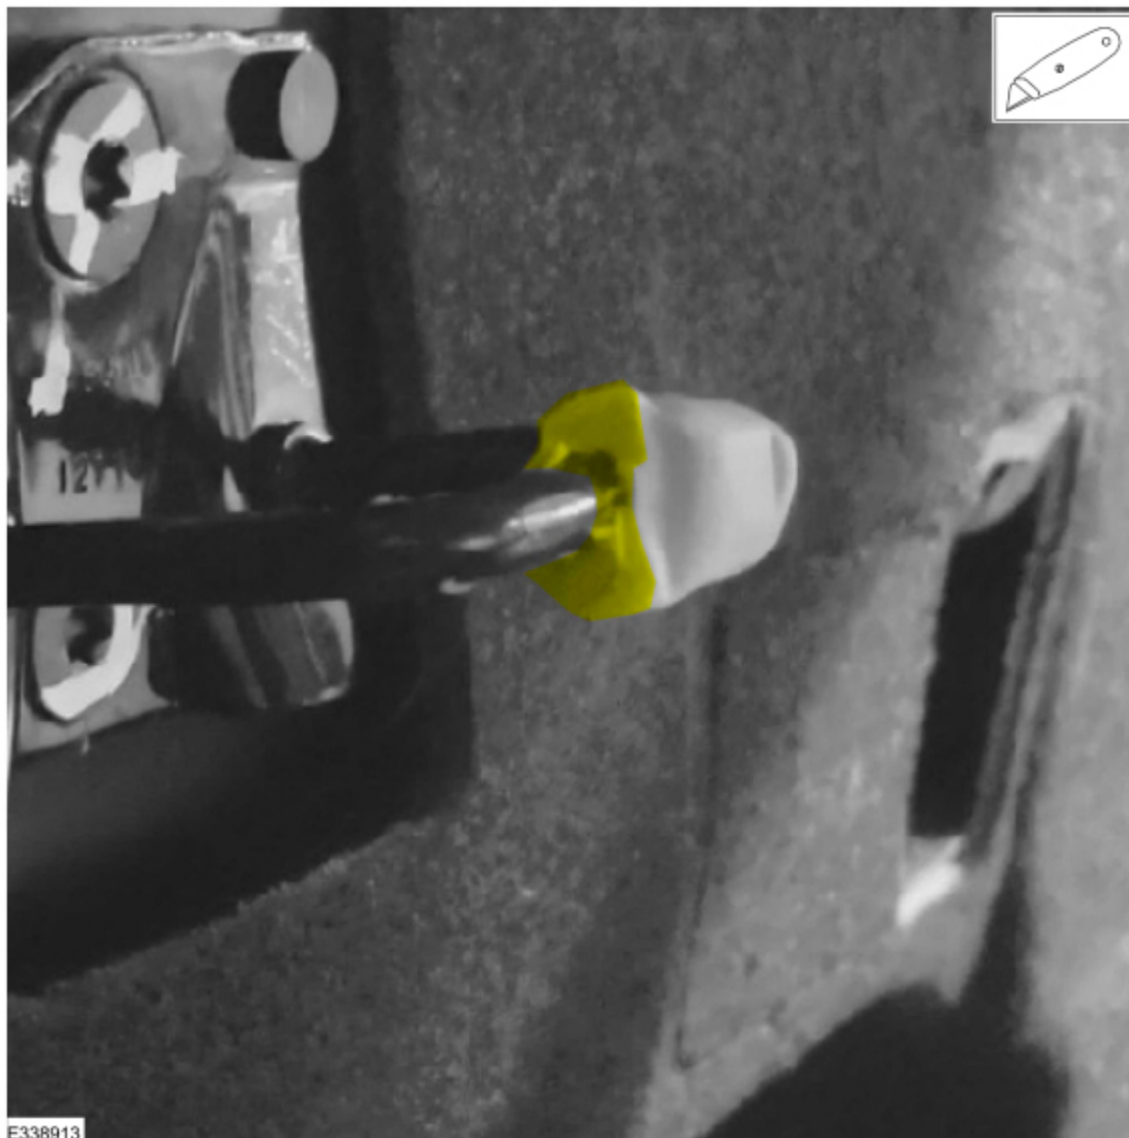
Figure 13

**19.** Using a knife or blade, cut away half of the modeling clay through the center of the impression to show a cross section of the impression left by the rear seat backrest latch. (Figure 13)

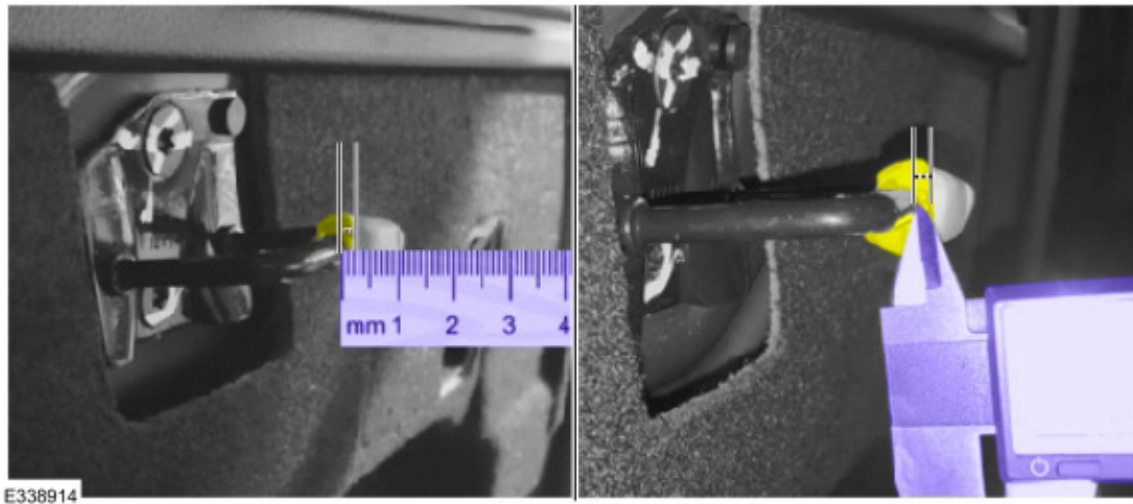
Figure 14

20. Using a ruler or dial caliper, measure the distance between the striker and the deepest part of the impression left in the modeling clay by the rear seat backrest latch. This measurement will be how much material is to be removed from each rear seat backrest bumper. (Figure 14)

21. Per the modeling clay measurement, mark the top of each rear seat backrest bumper in 4 places, 90° apart, to indicate the amount of material to be removed.
22. Using sand paper or sanding block (80 grit is preferred), remove the measured amount of material from each rear seat backrest bumper. Make sure that any shavings are cleaned prior to returning the vehicle to the customer.

**NOTE: The amount of material removed when using this measuring process should allow for reasonable latching efforts without creating any NVH related issues. Additional material may be removed to further reduce seat latching efforts for customer preference but removing too much material may result in rear seat backrest NVH concerns.**
